THE BLACKWELL SCHOOL

Chronology of Development & Use with Considerations for the Future

UTSA Students Involved

Instructor: Professor William A. Dupont, FAIA

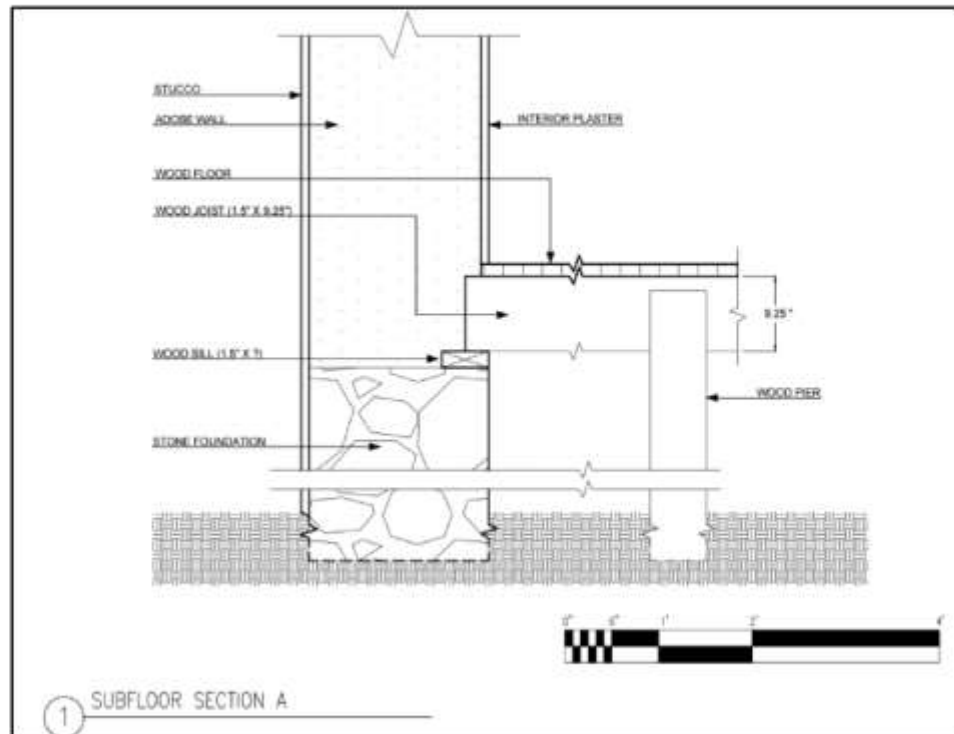
This diagram shows the adobe wall and the wood floor framing resting on the stone foundation wall. Drawing made by Gustavo Ochoa.

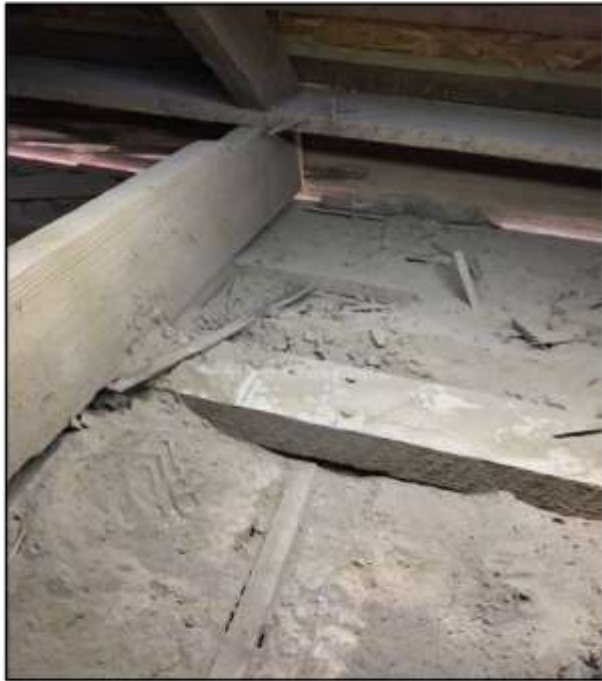
Photo shows 2" x 4" sill plate on top of adobe wall anchored to 1"x(3/4" actual) horizontal framing in adobe wall forming bond beam connection. Photograph by UTSA Preservation Seminar Class 2017.

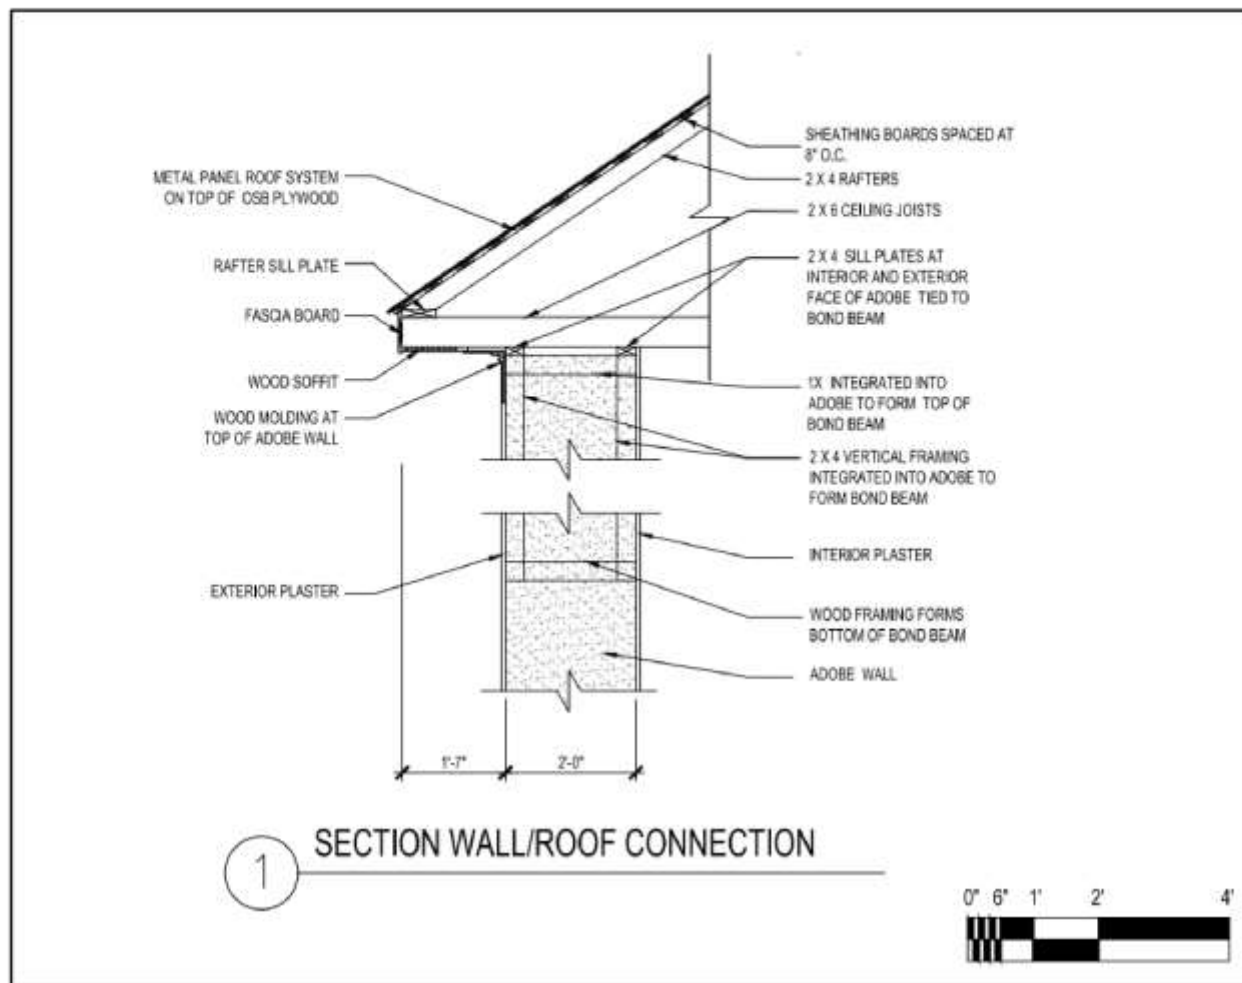
This drawing shows how the wood framing of the roof is connected to the adobe walls. Drawing made by Lisa Trail Garza.

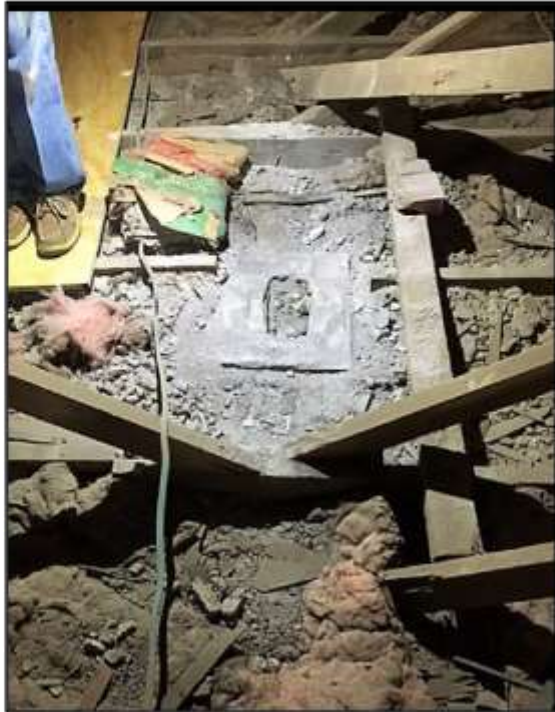
Two centrally located brick chimneys (now missing between attic and floor) penetrated the hipped roof. The easternmost of these two chimneys is visible in older photographs. The extant of roof framing bears witness to the former chimney locations. Measuring approximately 16" x 22", the chimneys are built into the interior adobe wall and are made of baked D'Hanis brick, a local brick manufactured in D'Hanis Texas starting in 1905. Although the chimneys have been

removed above the ceiling, from the attic, the top portion of the chimneys are visible in the adobe.

D'hanis brick chimney exposed at top of adobe wall, east central location. Photograph by UTSA Preservation Seminar Class 2017.

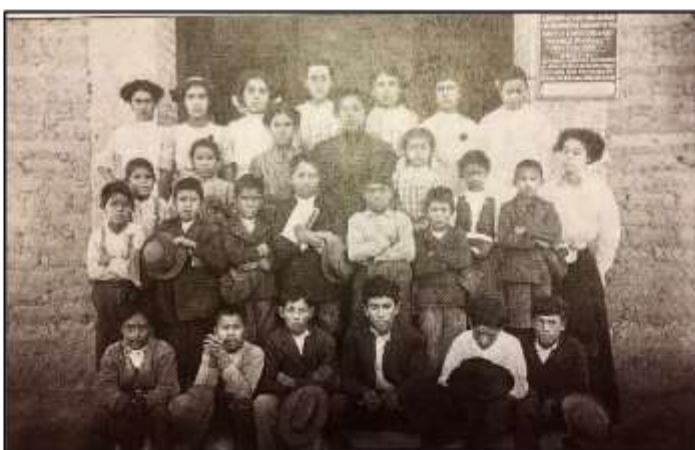
Mary Shannon's class in front of Blackwell School, circa 1910. Exposed adobe wall and brick piers at porch opening show first build construction. Photo courtesy of Blackwell School Alliance.

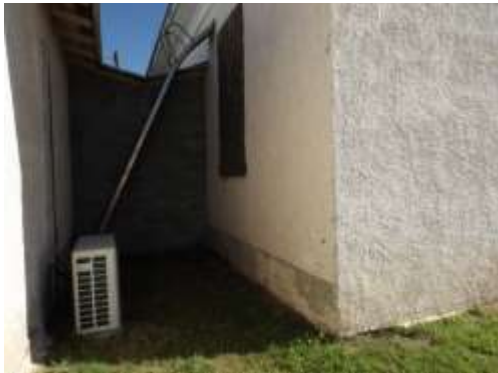
Image showing connection between band room and classroom.

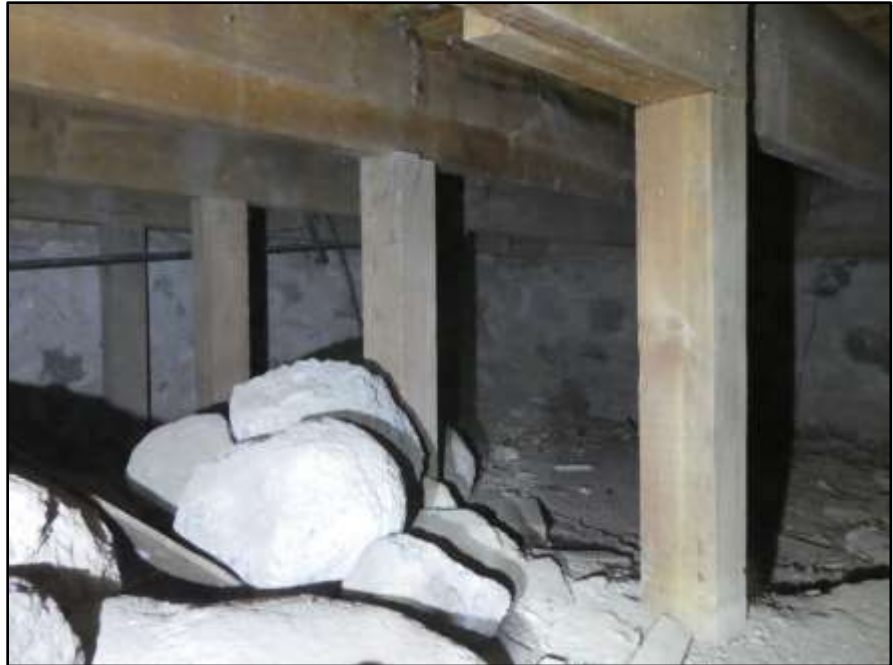
Beneath the south classroom (blue room), the wooden joists span north-south bearing on wood sill plates. The sill plates are set on the rock foundation.

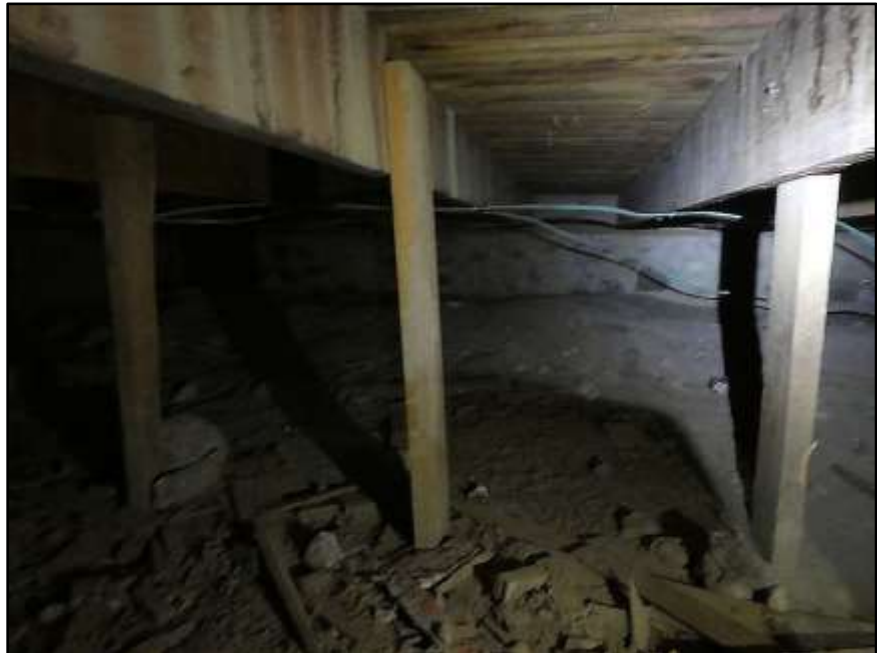
Joists are supported mid-span with the wooden boards nailed to the side of the joist to withstand the structural load of the floor.

The supports bear on the dirt floor. Despite applying the same framing method, there are differences in how the joists are being loaded.

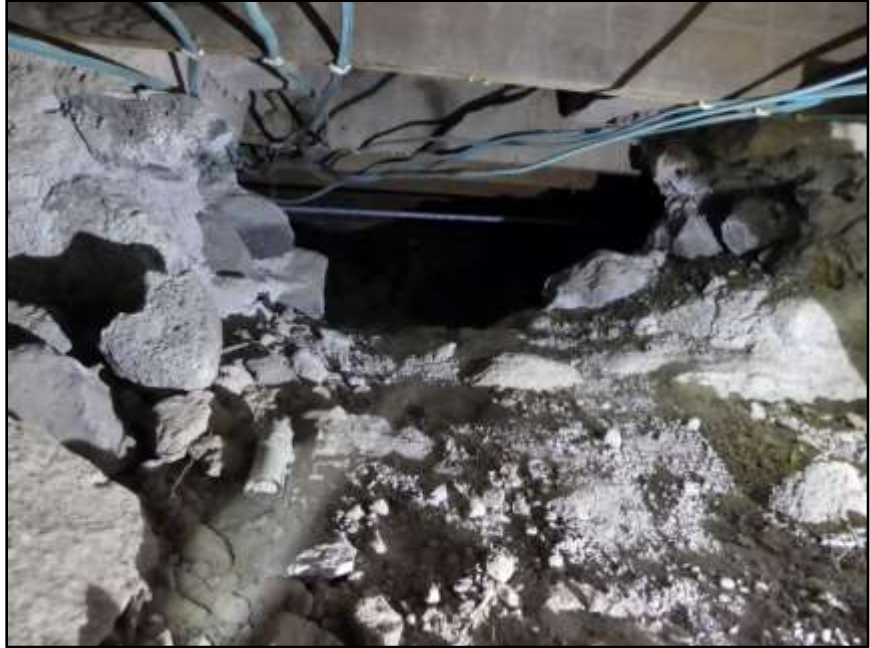
In the northeast corner of a classroom, the rock foundation was partially demolished to create an opening for electrical wiring to pass through.

Prior to the demolition, the rock foundation was continuous without interruption. Debris of rock and mortar remain from the partial demolition.

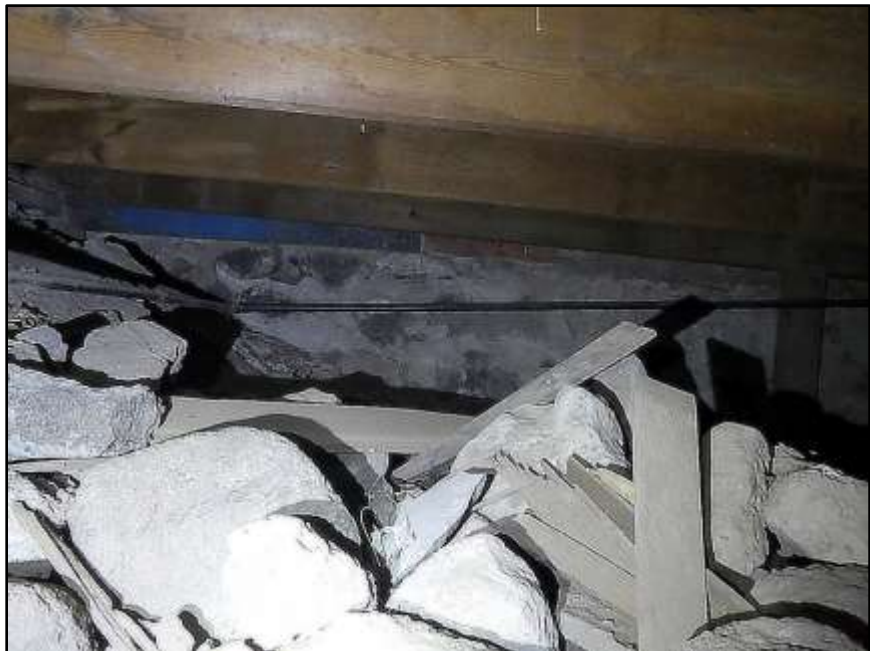
At the east foundation wall, there's a colored and natural wooden board on top of the rock foundation. It's slightly taller than the wooden sills adjacent. It's located where the front steps and landing were first built out of wood before being built out of concrete.

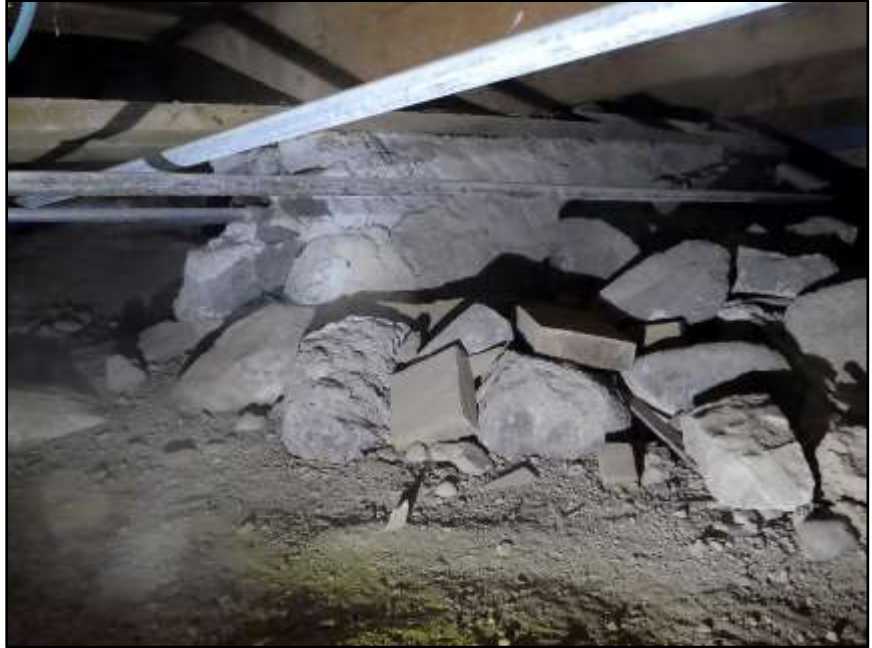
Under the front entryway, a stone foundation segment runs east-west supporting joists at mid-span. There is a plaster or cementitious coating on this segment. Two wooden sills are set on top of the stone foundation segment. The wooden joists bear on the sill plates. This foundation segment may have been disassembled for pipes. There is debris of stones piled nearby.

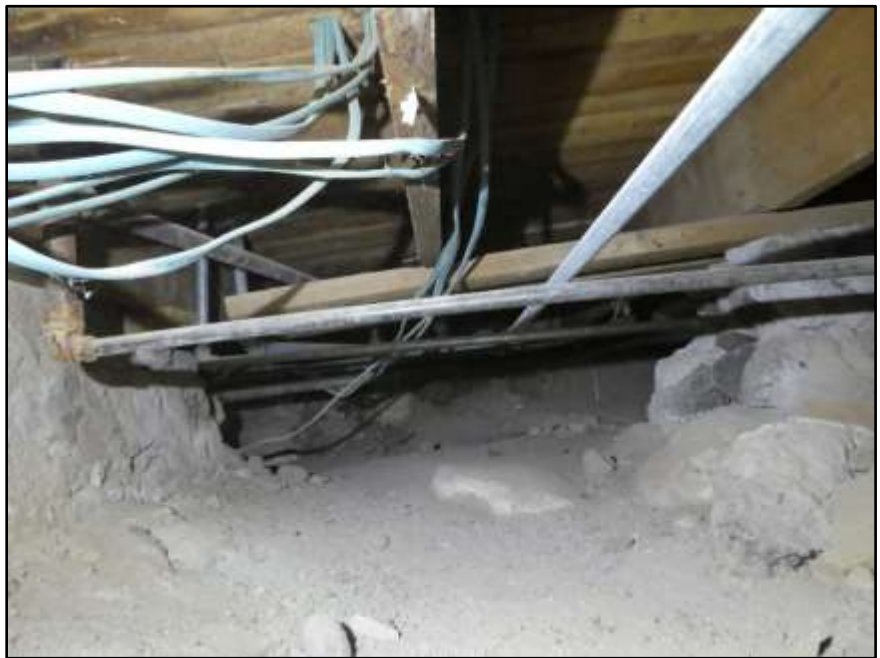
The two wooden sills laying on the rock foundation extend into the void that may have been a solid wall previously. They are cantilevered and bowing downward. The cantilevered sills no longer support the wooden joist above.

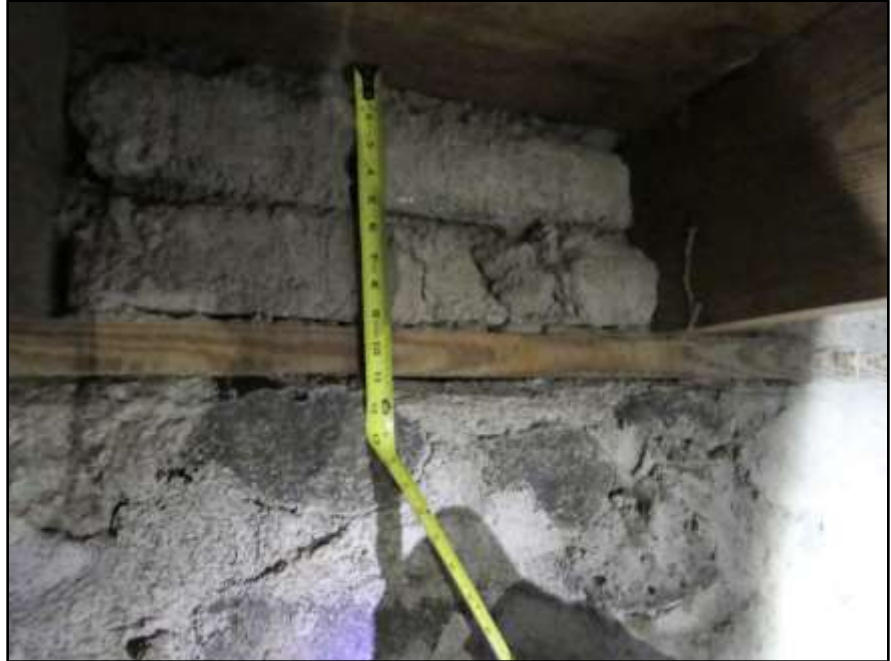
Between the joists, adobe bricks set on lime mortar sit on top of the wood sills and rock foundation. It's undoubtedly exposed from the subfloor.

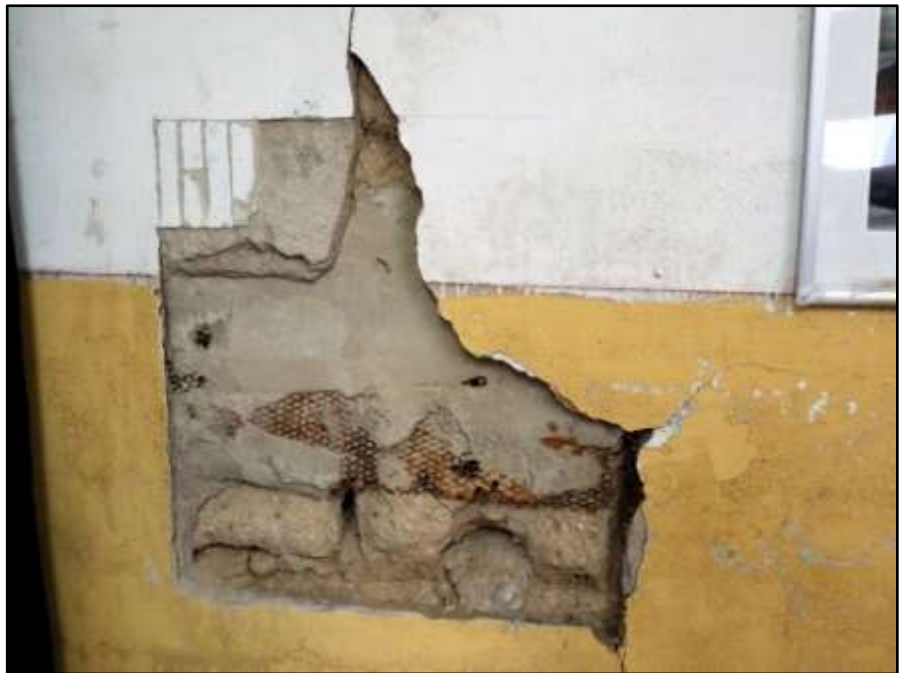
A minor deterioration of the cementitious plaster of the internal wall seen from the north classroom (white room) bares adobe bricks identical to the adobe bricks found beneath the subfloor. This indicates the walls are composed of adobe bricks.

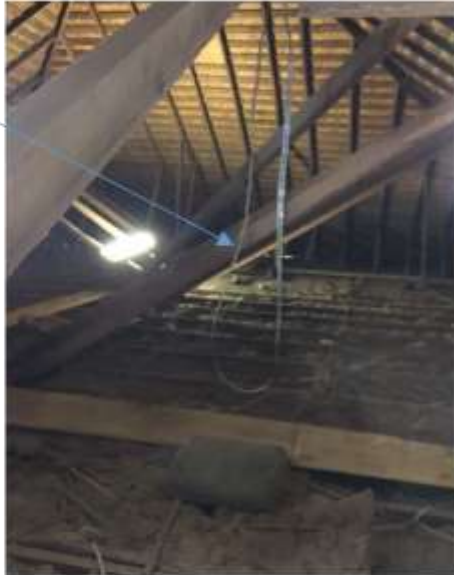
At the roof above the chimney, there is evidence of water penetration on rafters and sheathing boards, however the wood shingle roof has been replaced and the new metal roof appears to be dry and watertight. The visible water damage may have been caused from deterioration of the (wood shingle) roof at the valley between the gable and hipped roof. Although roof rafters appear to be cut directly above

Metal strap hanging from rafter may have supported metal ducts.

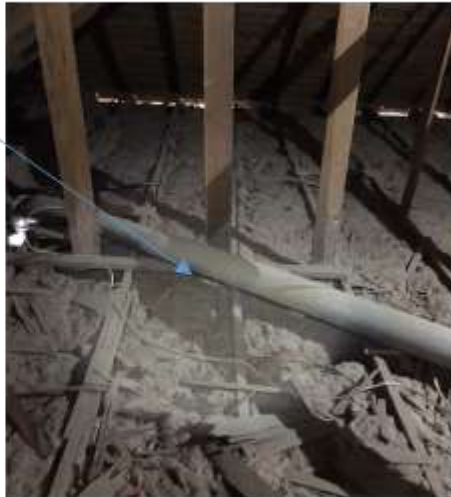
the chimney, it is difficult to determine if the chimney previously extended through the roof, or if the rafters were cut to accommodate metal ducting which may have extended from this chimney to the "east" chimney of the interior adobe wall. Existing metal "straps" anchored to nearby rafters may have supported a metal duct exiting the chimney and loose metal ducting was found in the attic nearby.

Disconnected metal duct found in attic near chimney.
