**For the Historic Blackwell School (1889-1965)
Marfa, TX**

A Conditions Assessment and Preservation Recommendations

Fieldwork and Report: Jean Fulton, M.A.

Preservation Programs Coordinator and Senior Program Manager
Cornerstones Community Partnerships (Mesilla, NM)

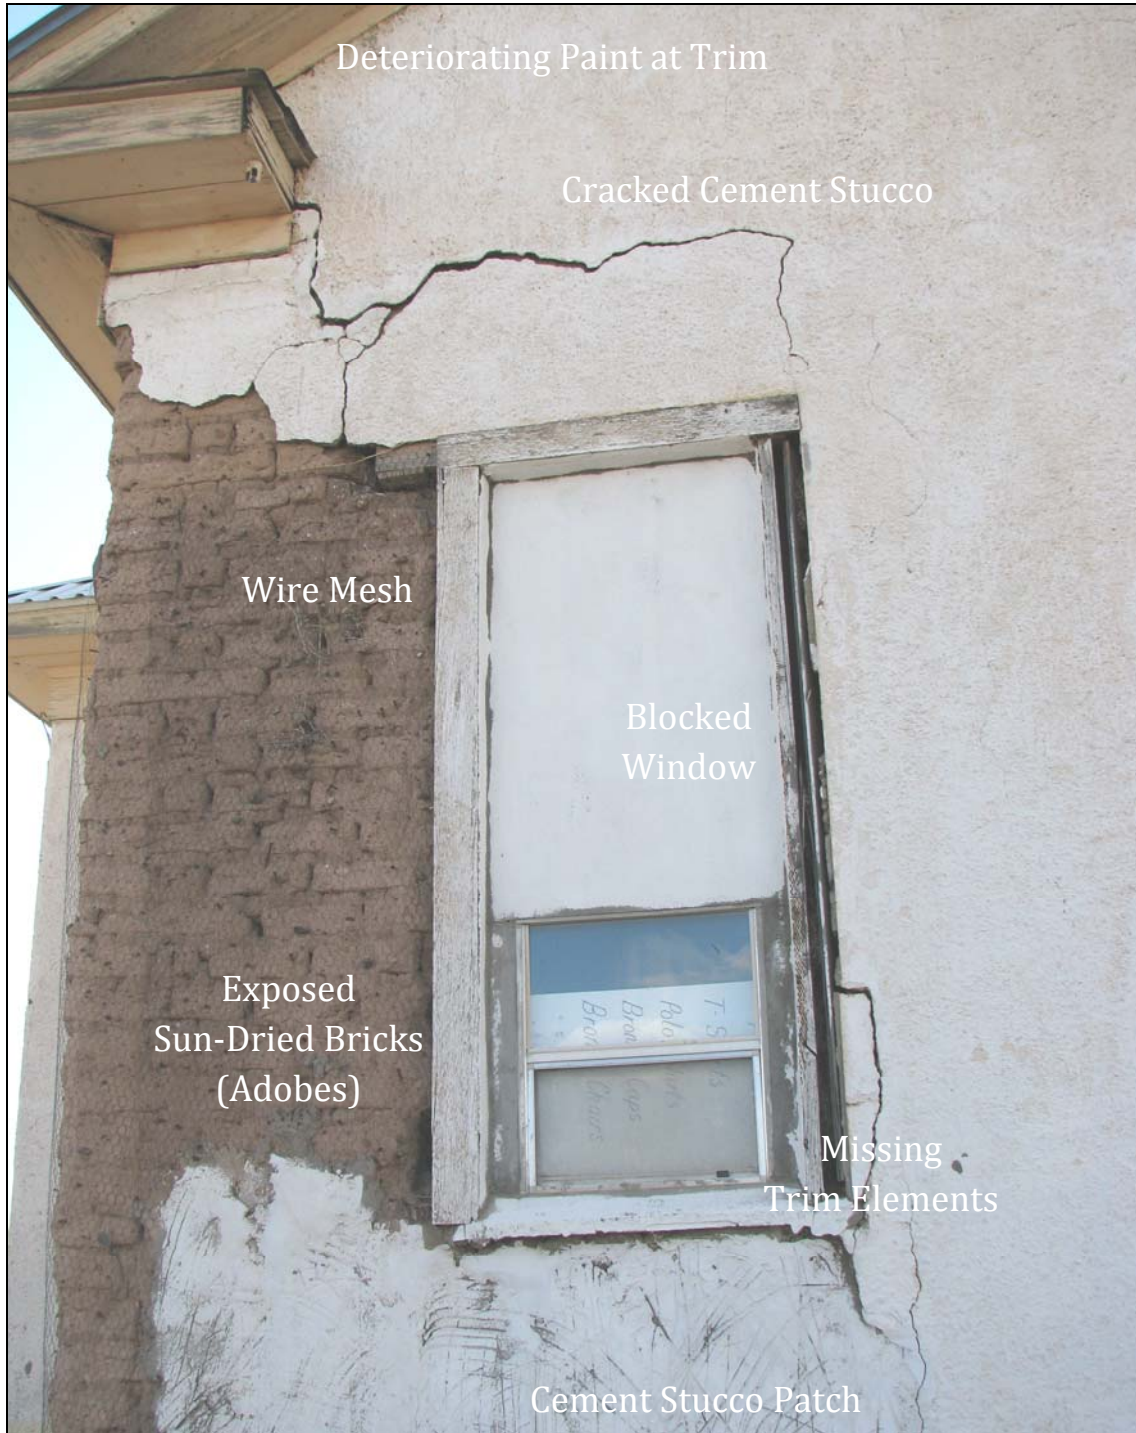
Deterioration at Front Façade Caused by the Addition of Cement Stucco

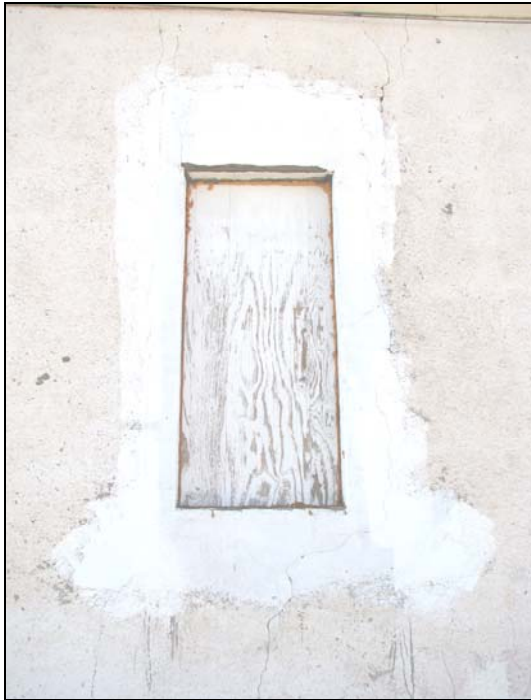
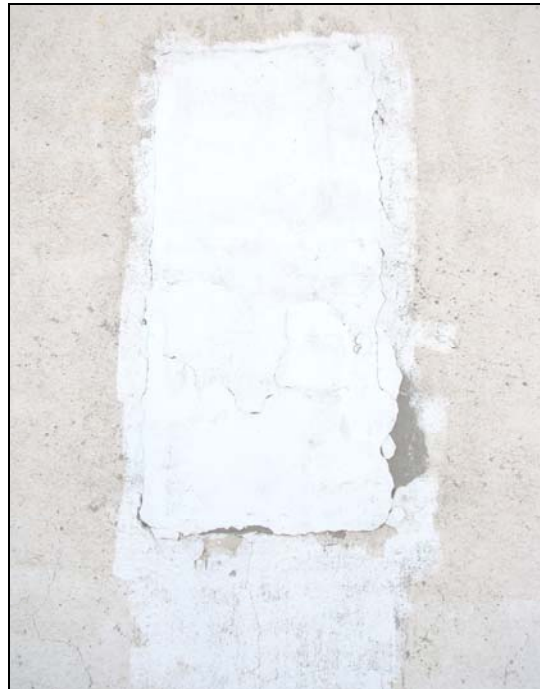
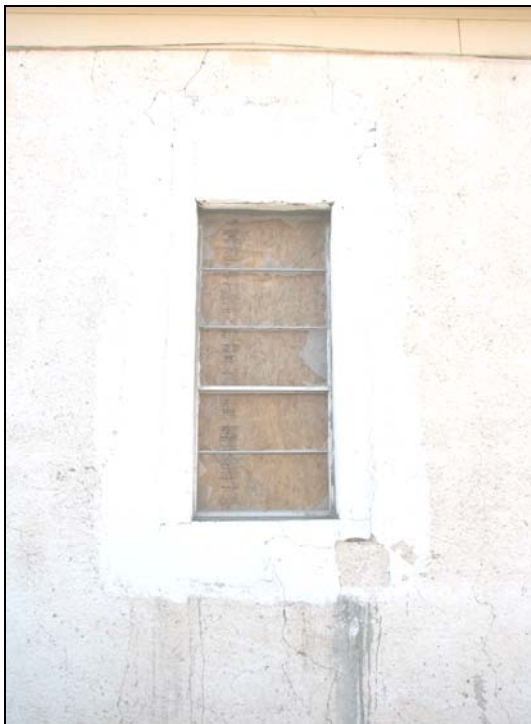
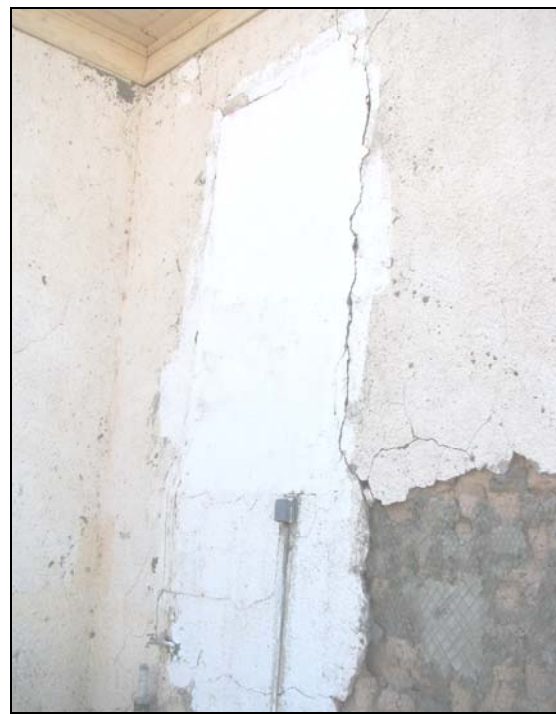
Photo-Documentation: Window Openings

Nearly All of the Historic Windows Have Been Removed

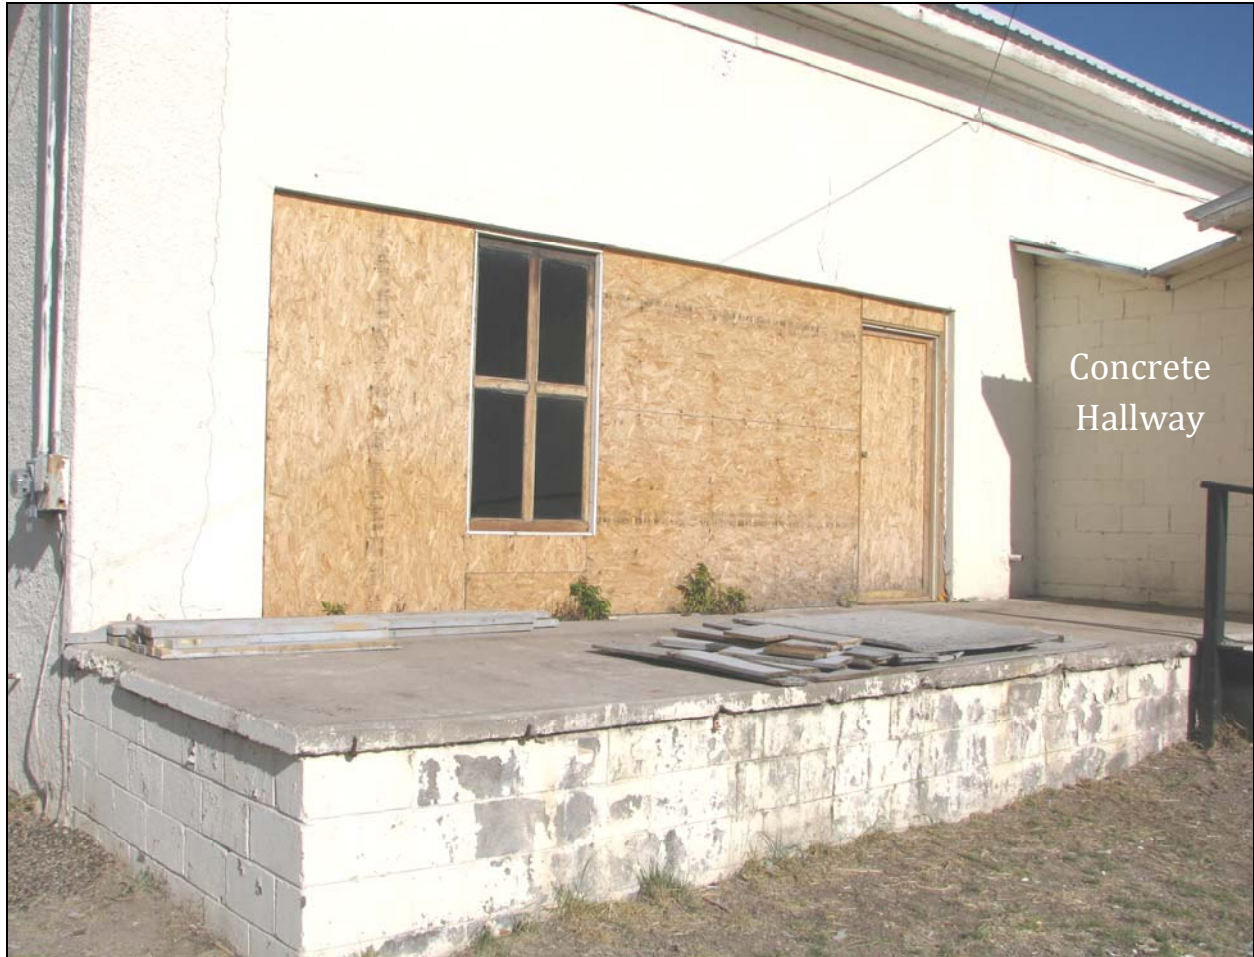
Photo-Documentation: Rear Elevation

A Rear Adobe Wall Has Been Replaced Using Stud Framing. Please Note the Addition of a Concrete Loading Dock and Wood Ramp, and the Faulty Roof Design at the Concrete Hallway Between the Main Building and the Band Room. Americans with Disabilities Act (ADA) Issues Will Need to be Addressed During the Upcoming Preservation Effort.

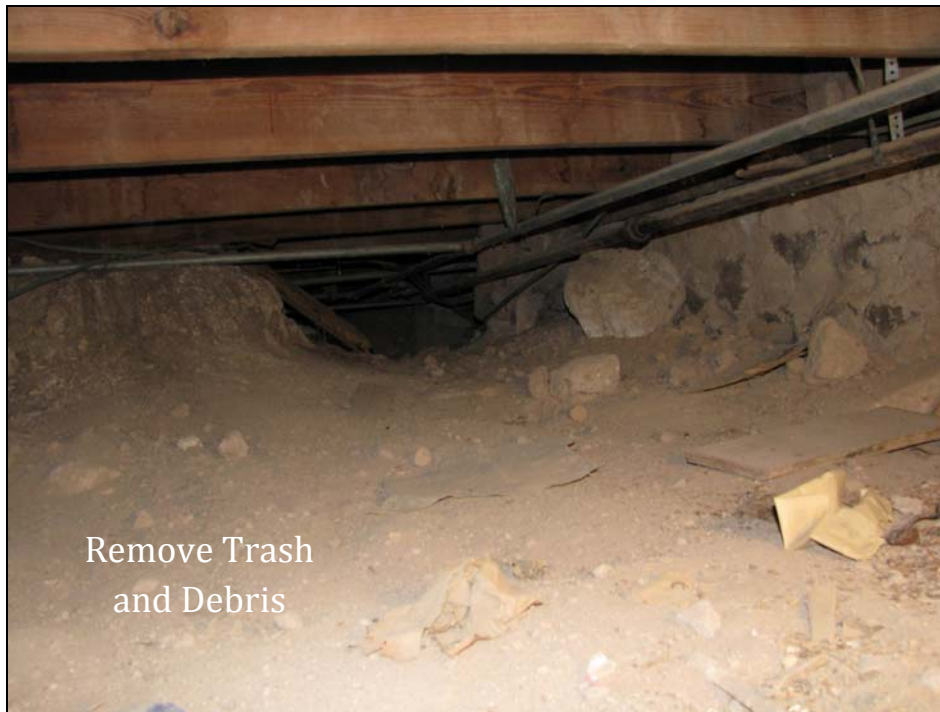
Photo-Documentation: Crawl Space Beneath the Floors

The joists sit on top of a rock wall that provides more than adequate clearance and ventilation. None of the joists shows any signs of deterioration.

The vertical struts sit on top of wood blocking. Many are loose and need to be shimmed or reattached.

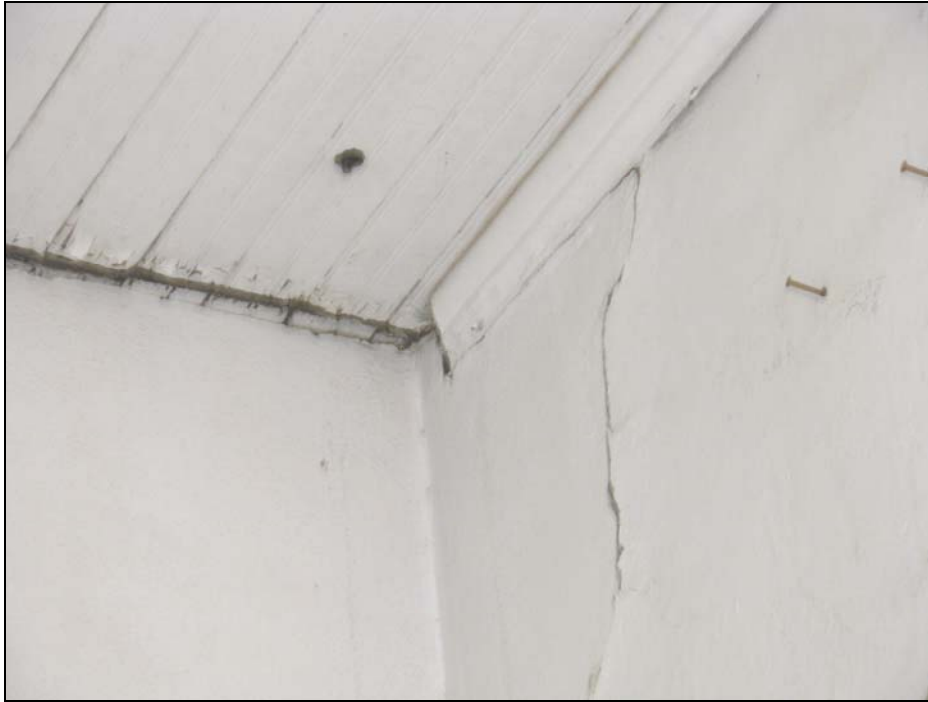
Interior trim pieces are missing, including sections of crown molding at the ceiling, wainscoting, baseboard, shoe mold, and chair railing. Enough original material remains, however, to replicate the missing trim pieces.

Latex paint and other finishes are spalling.

Recommend replacing original finishes (e.g., mud plaster, lime wash, etc.) and replicating the missing trim in each room.

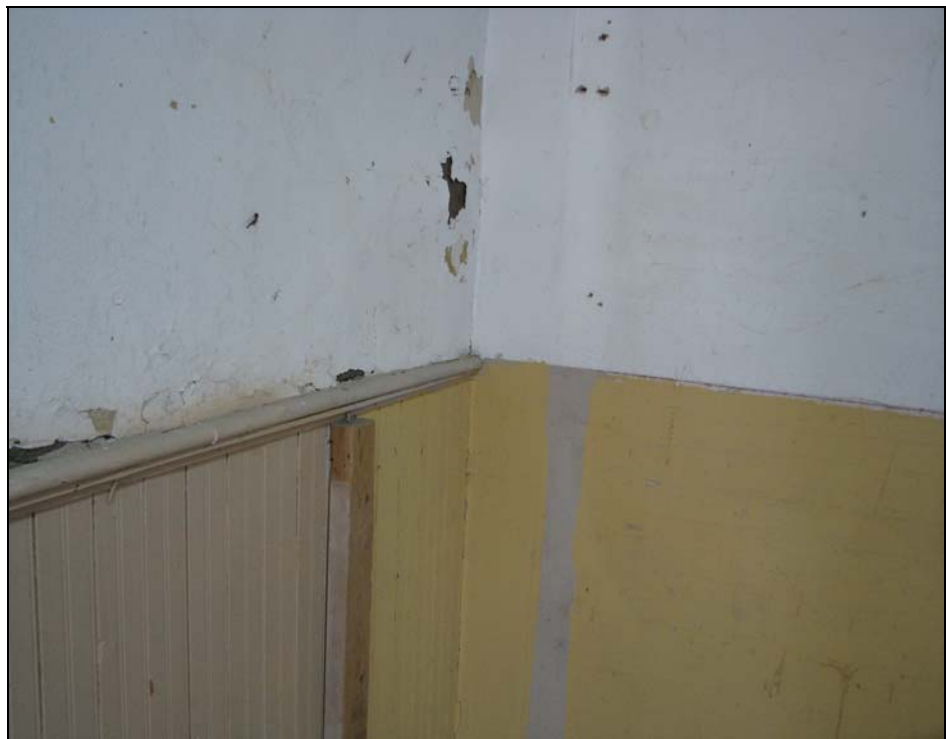
The Interior is in Need of Routine Maintenance.

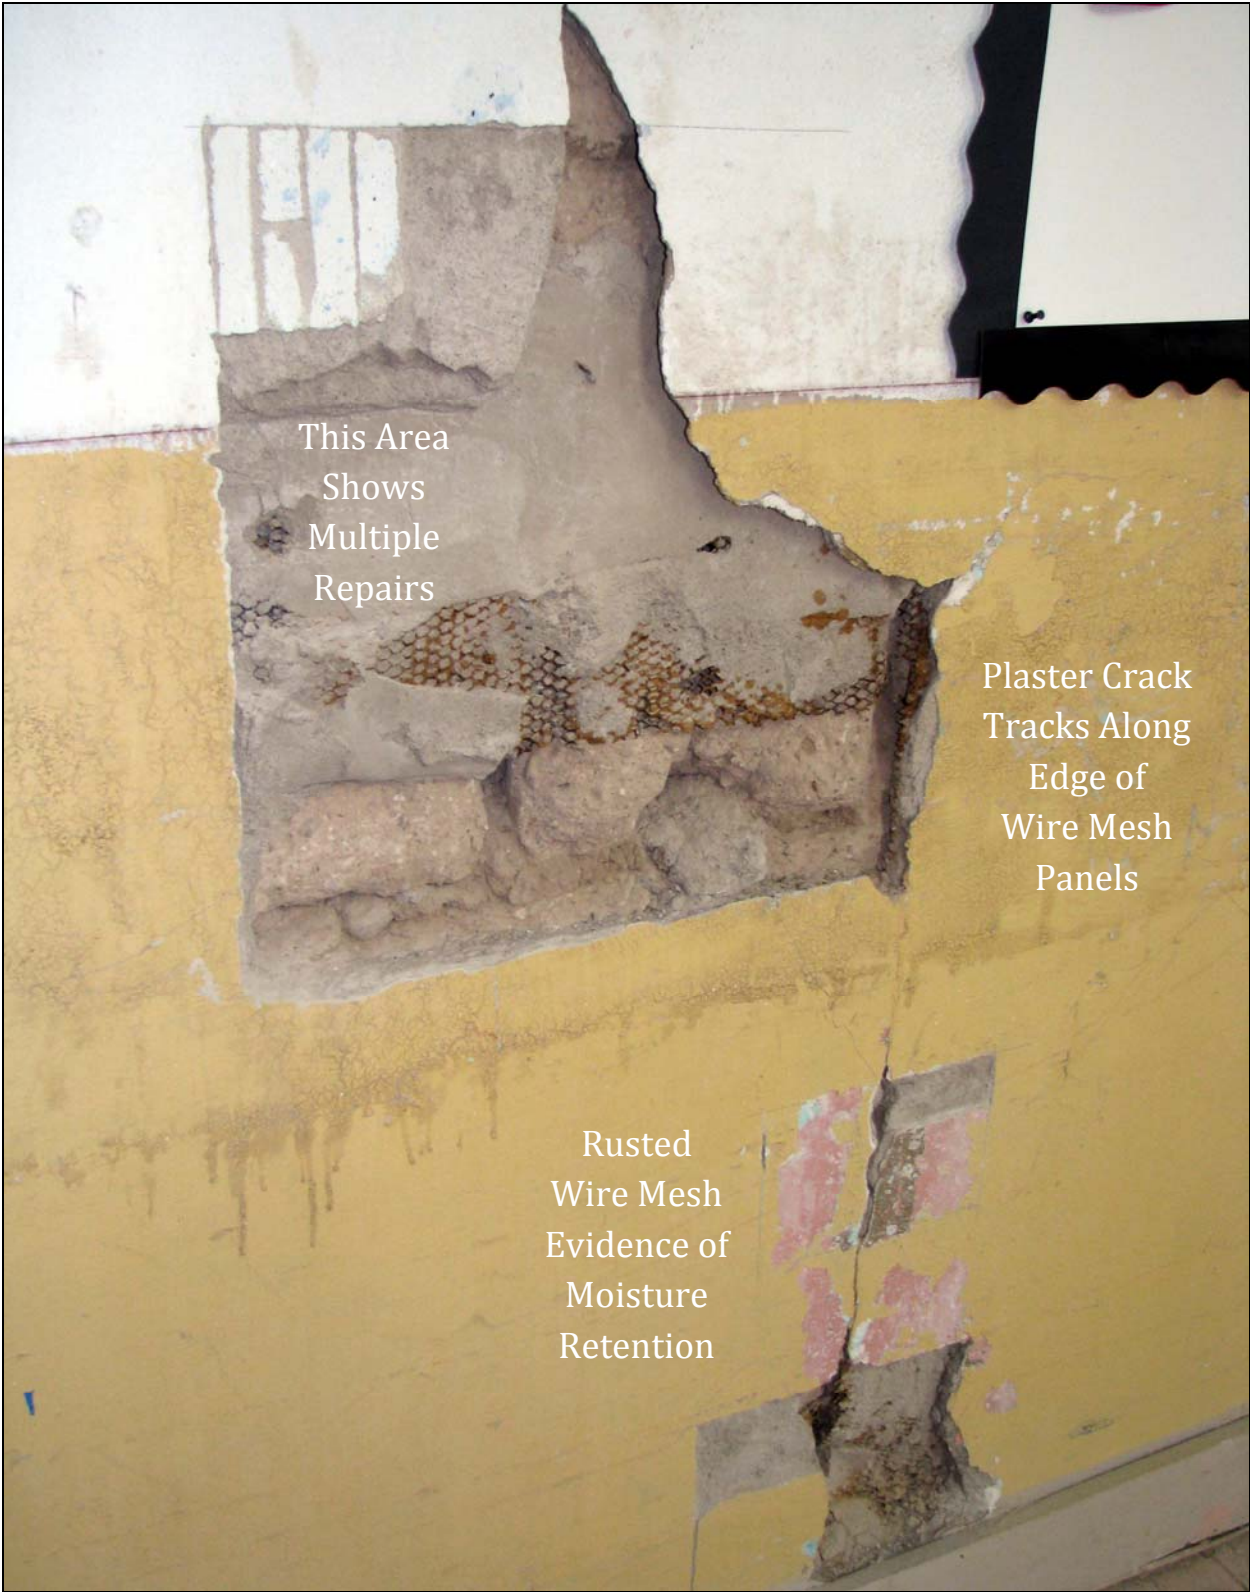
Photo-Documentation: Interior Plaster

This Area Shows Multiple Repairs

Plaster Crack Tracks Along Edge of Wire Mesh Panels

Rusted Wire Mesh Evidence of Moisture Retention

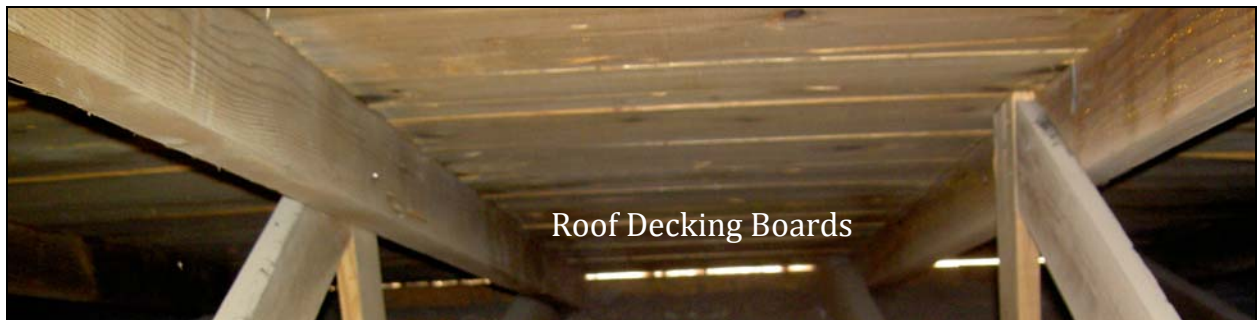
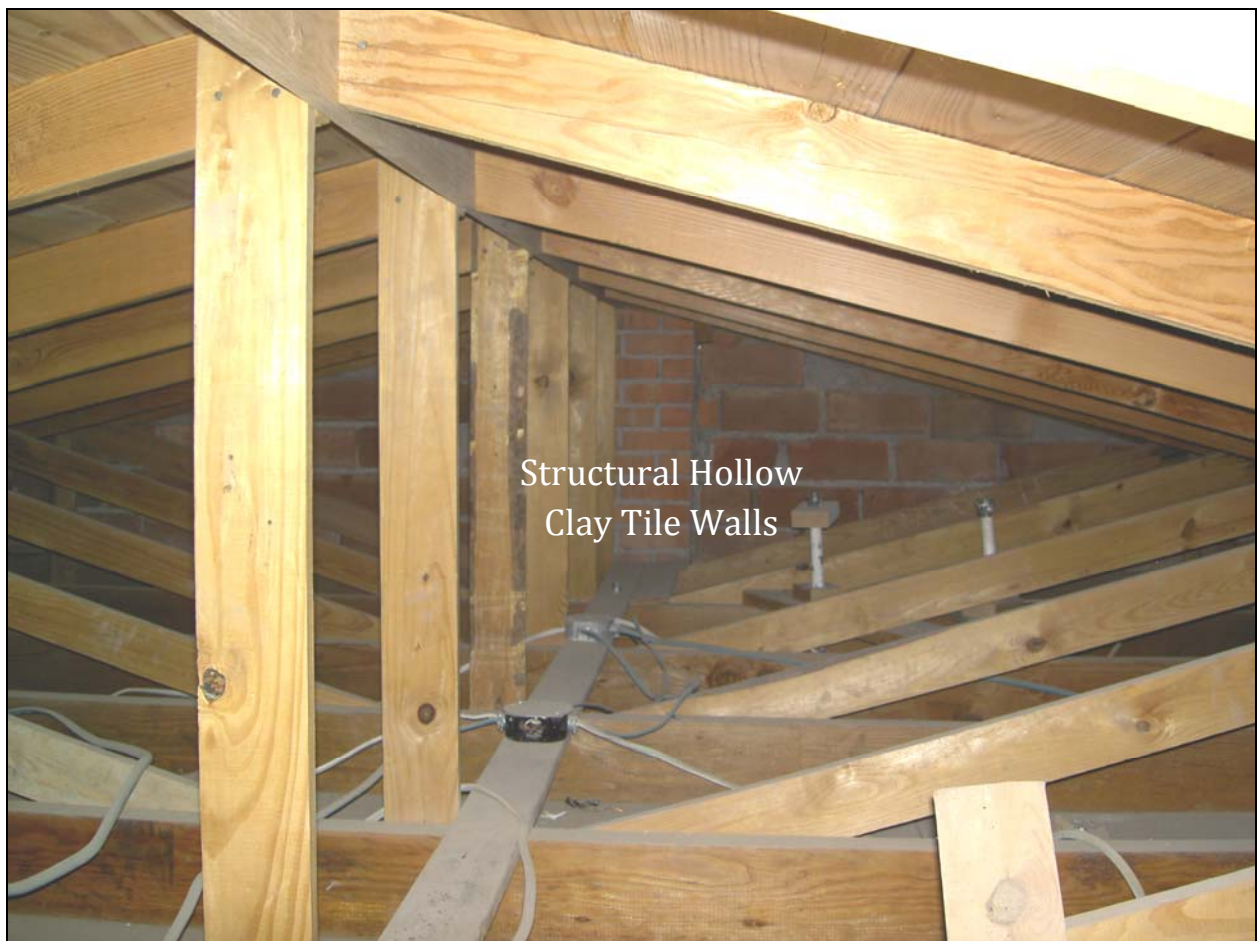
Band Room Roof Framing Investigation.

2" x 4" Rafters and Bottom Chords with 1" x 4" Vertical Supports: No Evidence of Stress, Deterioration, Leaking, or Pest Intrusion Noted During an Inspection of the Framing System Above the Band Room.

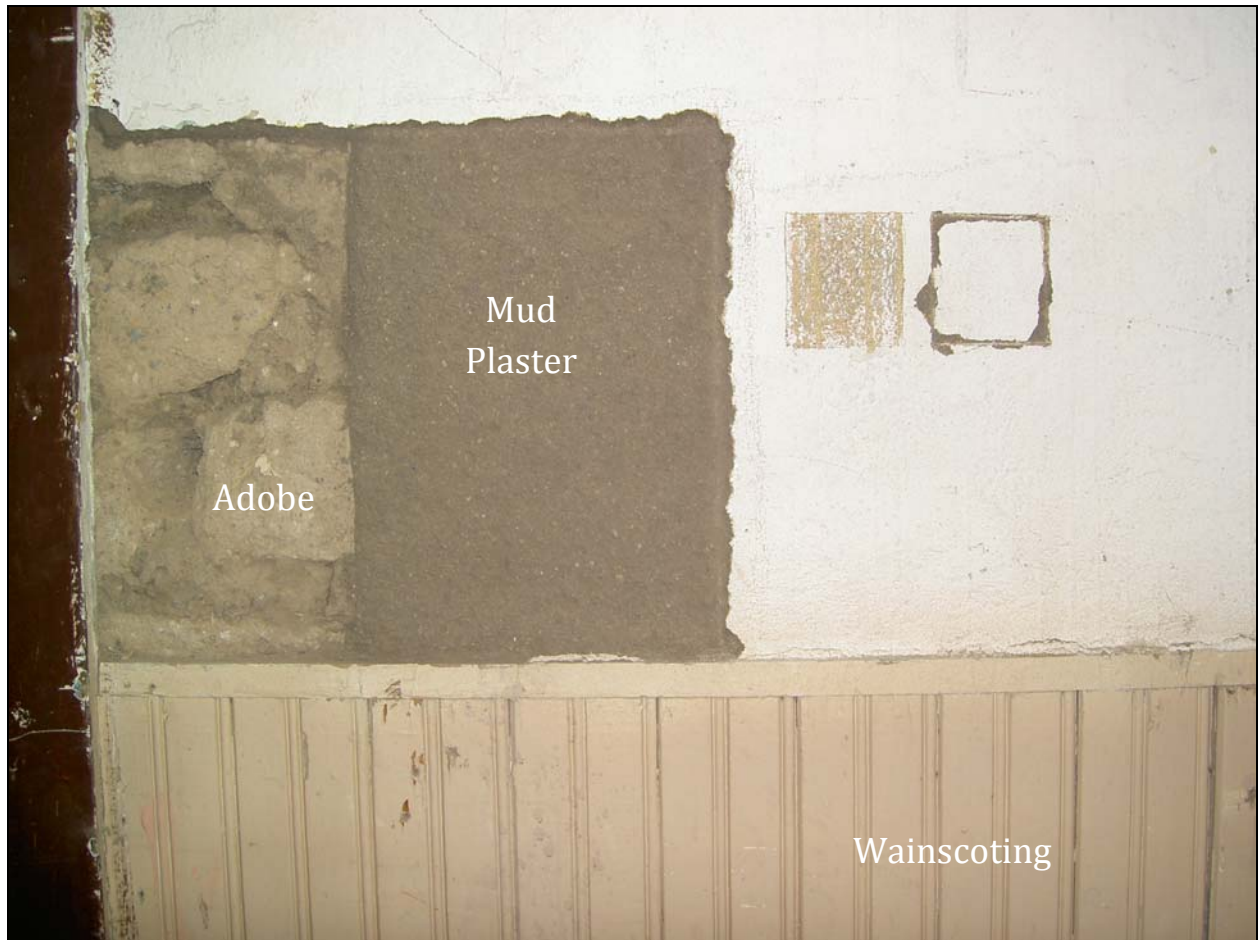
Intrusive Investigations at the White Room (South Wall) Reveal Latex Paint, Lime Wash (Verify) and Mud Plaster Applied to Original Adobe Wall Above the Beaded Wainscoting.

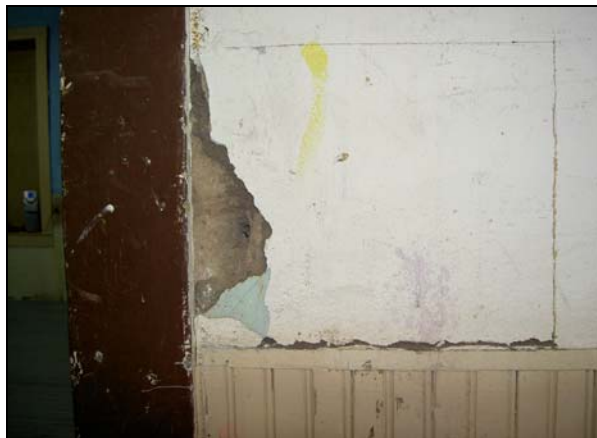
Photo (Left) Shows the Condition of the Wall Prior to the Layer-by-Layer Intrusive Investigation.
