THE BLACKWELL SCHOOL

Chronology of Development & Use with Considerations for the Future

UTSA Students Involved

Instructor: Professor William A. Dupont, FAIA

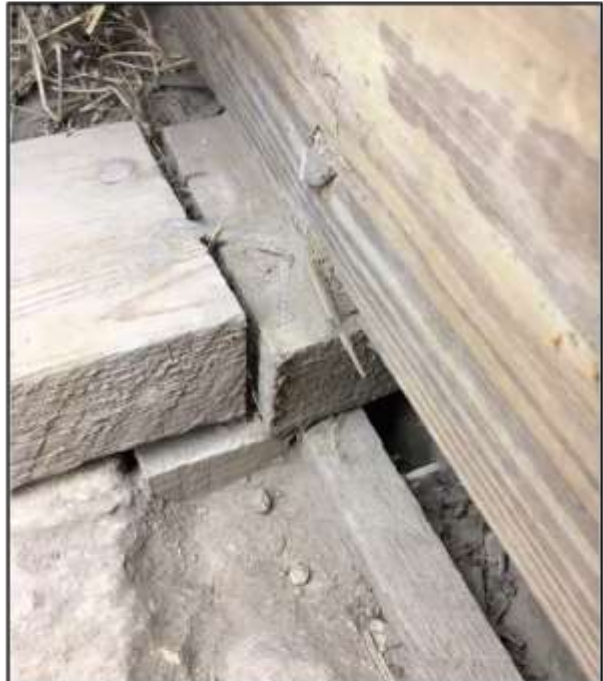
Figure 1 Bond beam connection at adobe wall showing top sill plate anchoring to vertical 2" x 4" framing. Photograph by UTSA Preservation Seminar Class 2017.

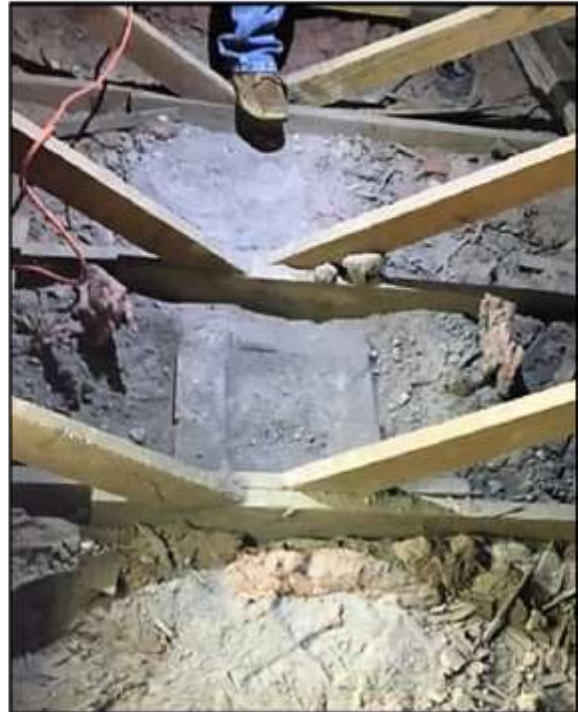
D'hanis brick chimney exposed at top of adobe wall, west central location. Photograph by UTSA Preservation Seminar Class 2017.

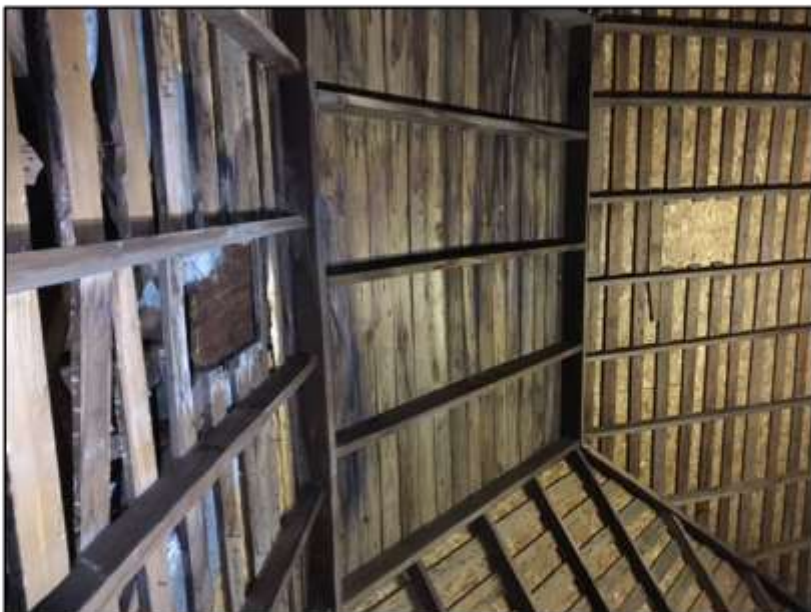
Indication of east and west central chimney penetrations at roof rafters/deck. Photograph by UTSA Preservation Seminar Class 2017.

At the roof above the chimney, there is evidence of water penetration on rafters and sheathing boards, however the wood shingle roof has been replaced and the new metal roof appears to be dry and watertight. The visible water damage may have been caused from deterioration of the (wood shingle) roof at the valley between the gable and hipped roof. Although roof rafters appear to be cut directly above

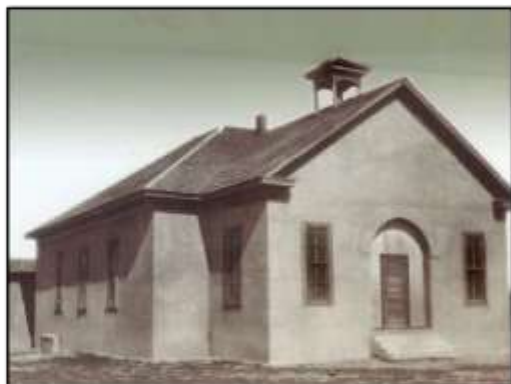
An old photograph shows an open framed belfry located at the midpoint of the gable ridge above the front porch. In the attic, evidence of a square roof penetration and supporting framing and bracing at the gable ridge confirm the belfry's location.

Photo of Blackwell School, post 1910, which shows the east central brick chimney and belfry. Also visible is the projecting brick arch. Photo courtesy Blackwell School Alliance.

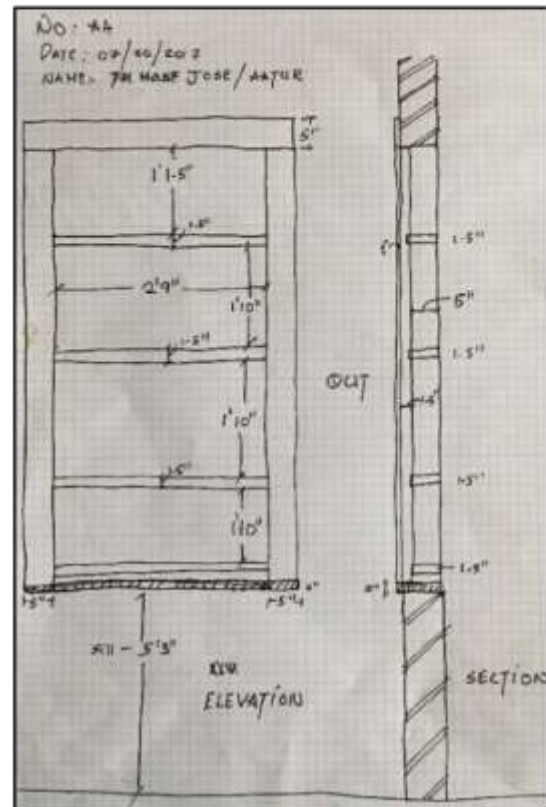
This dimensioned field drawing by Aatur Chawda, of the wood window located on the west wall of Blackwell School, shows the only remaining window frame from the buildings initial construction period.

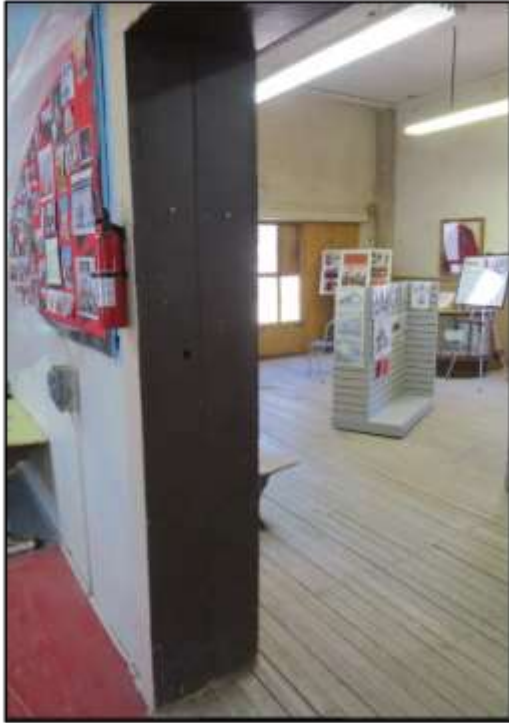
Hinge marks on the 6' x 7' cased wood opening connecting the two classrooms, indicate there was a door separating the rooms. Photograph by UTSA Preservation Seminar Class 2017.

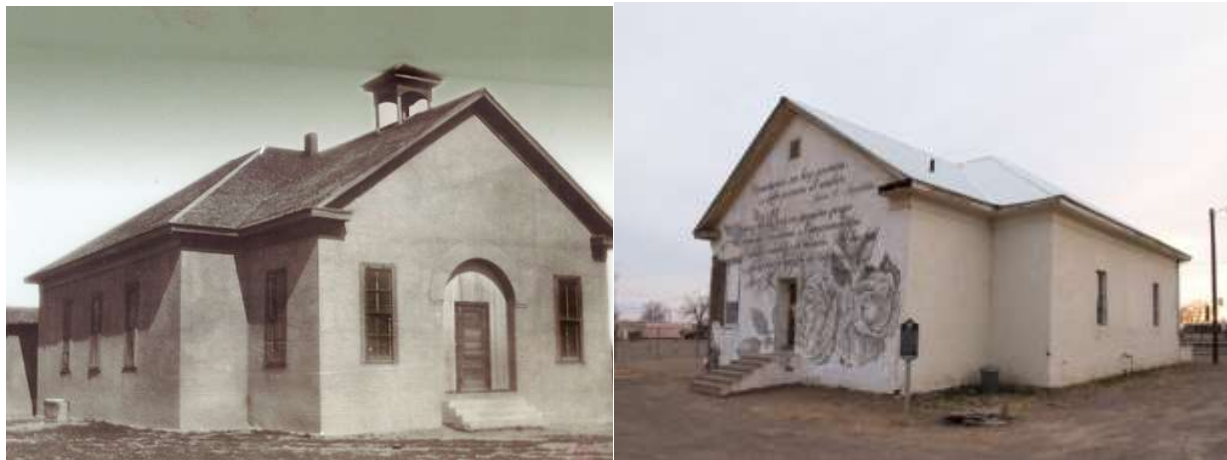
The post 1910 modifications of the Blackwell school include plaster on exterior adobe walls and brick arch on the east façade. All the exterior walls were whitewashed. Prior to 1933, a rectangular band room of 602 square feet and 10 feet high was added on the west side (rear) of the school, built of 12-inch clay tile wall. Also, two manufactured brick chimneys and a belfry were removed from the front gable. Roofing materials were updated to metal sheets. Concrete stairs of 84" x 34" took the place of wooden stairs at the entrance. By the 1990s, the brick arch and a window had been removed from the front façade. A concrete beam was installed in place of the arch, and the gable end was rebuilt with a louver and new wire plaster to hold the exterior stucco. Top hung rolling shutter was installed on the west exterior wall of the classroom, which was donated by Superintendent Robinson.

Images showing modifications of post 1910 era.

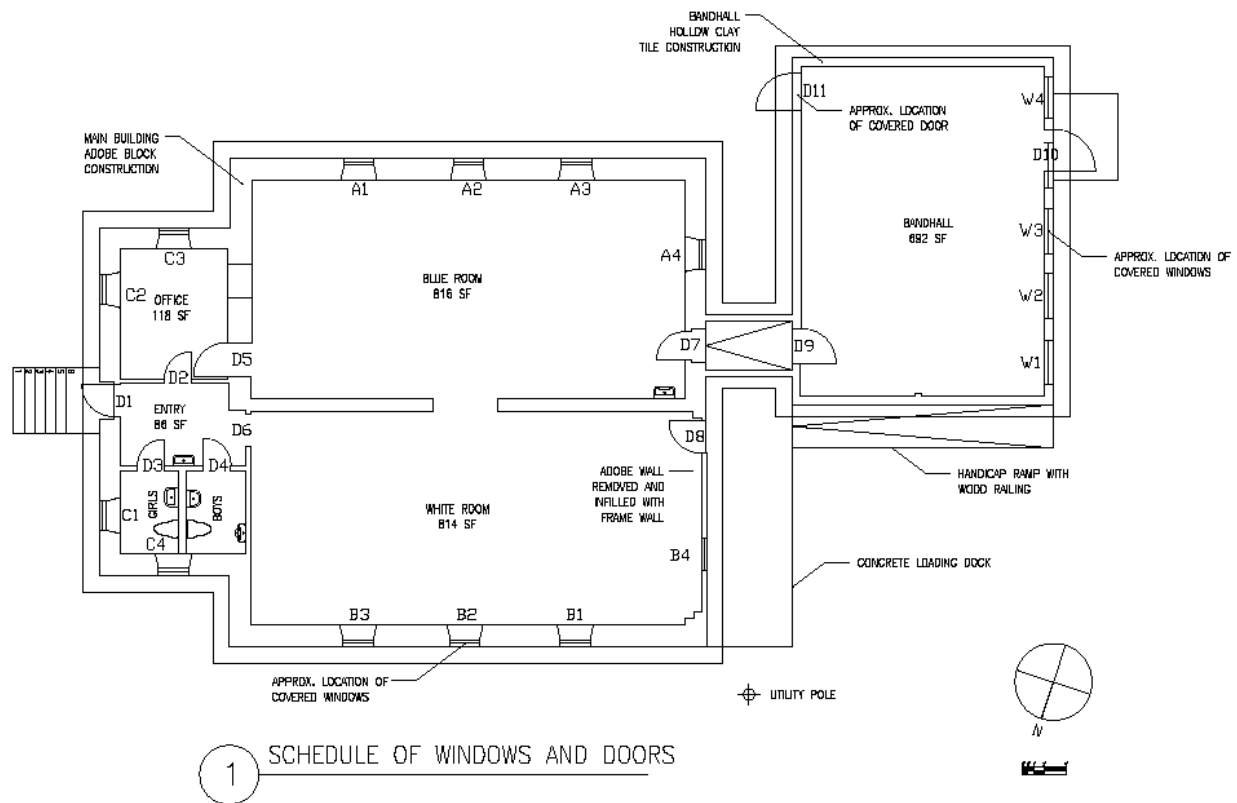
Post early 1970s modification.

One of the major modifications of the Blackwell School in the early 1970s was the replacement of wooden window frames with reduced aluminum window frames. Window sizes were reduced to 7'x4' outer frame and nine existing windows were sealed, namely C4, W1, W2, W3, W4, W5, A2, A4 and B2. There is clear visual evidence of former windows on the west side of the building in the band room W1, W2, W3, W4 and W5 now closed in with stucco finish on the exterior. The window A4 was discovered to be partially intact, including the weight pulley system for the operable sash. There is a possibility of window C4 which could be closed after the construction of the toilets for girls and boys in 1970 era. The windows C1, C2, C3 on the east side are known to be reconstructed completely in 2011.

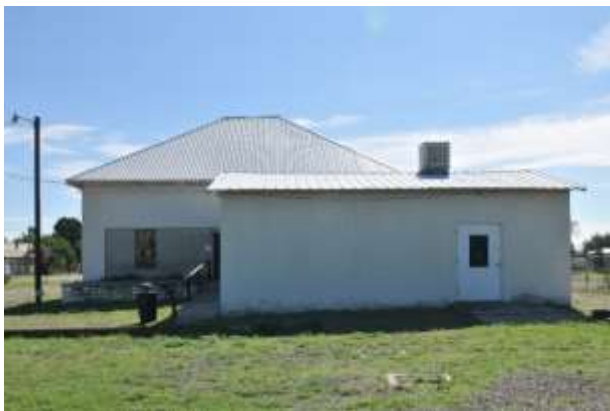
Image showing sealed windows from band room.

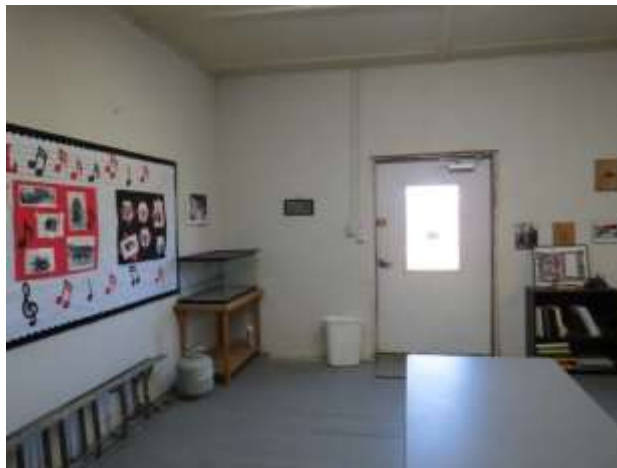
In the interior bathroom flooring was updated by implementing ceramic floor tiles. Plumbing and electric system was also updated. Wainscoting was dismantled from some of the interior walls. The band room ceiling was updated and flooring was painted in 2010.

Image showing modification of band room.

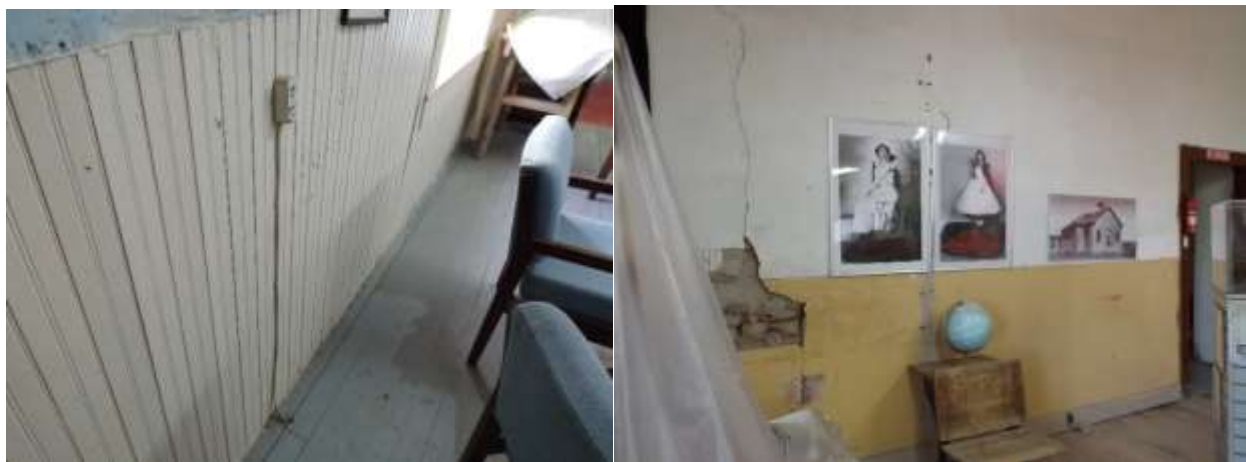
Images showing interior modifications.

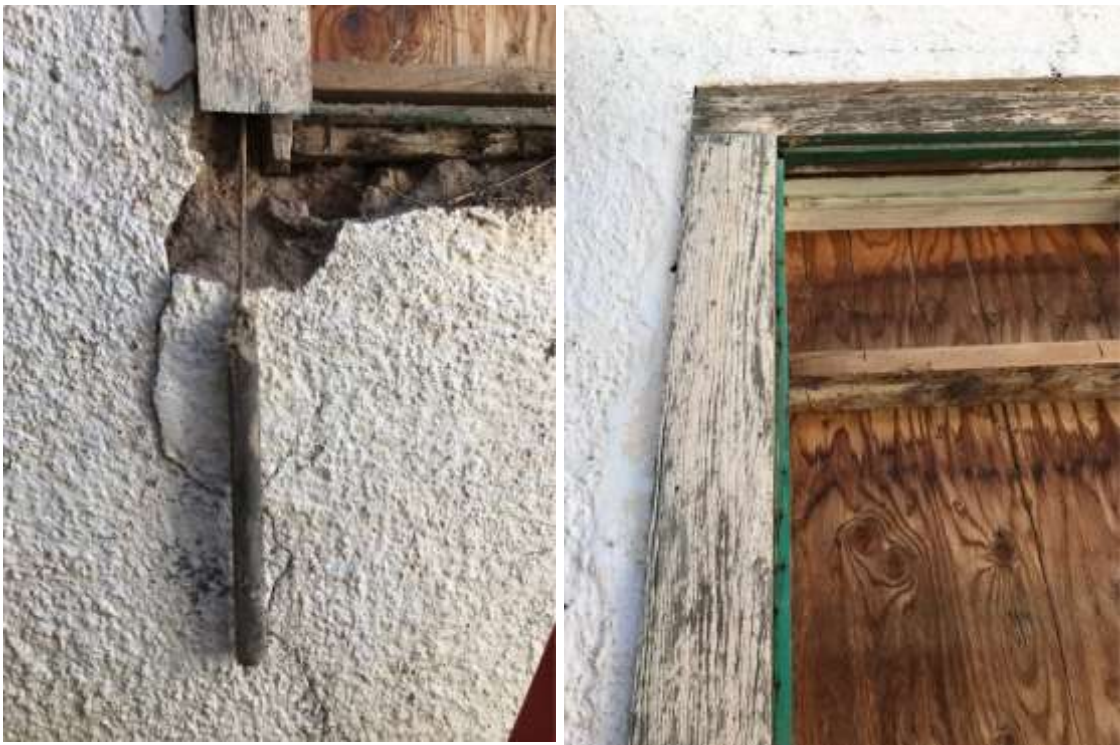
A4 window with pulley system.

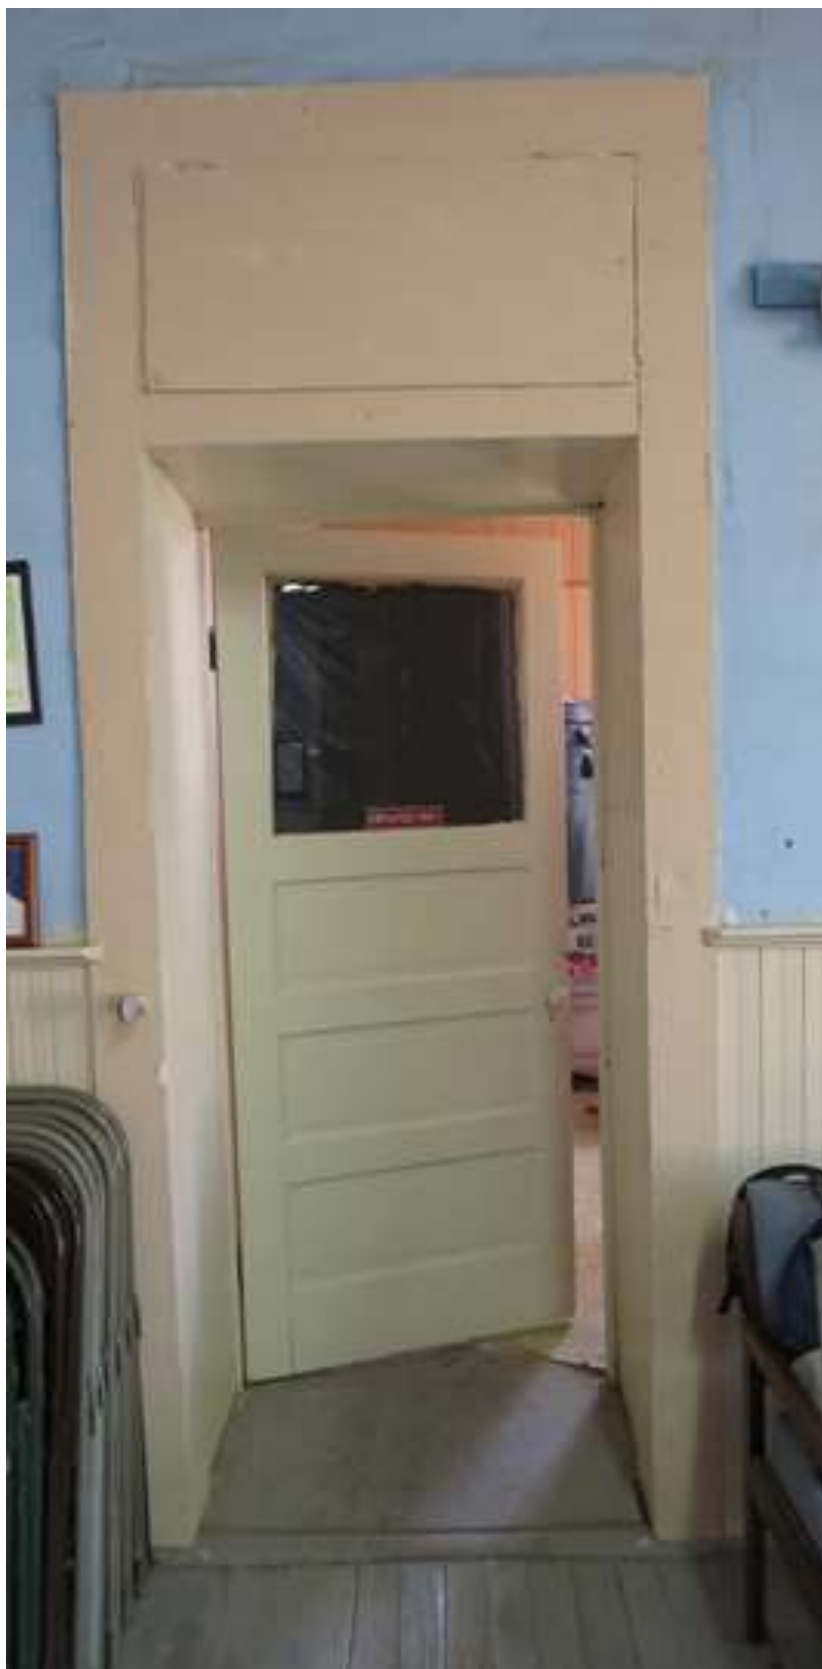
A1 WINDOW

D5 door and on right the operable transom

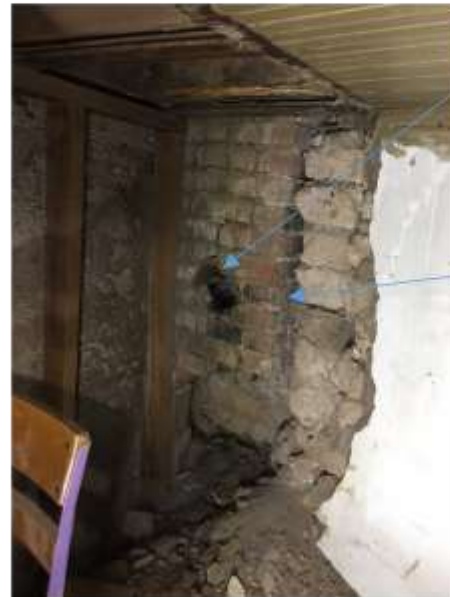
Flue pipe opening in chimney

Gap between adobe and brick chimney.

adjacent adobe wall is exposed and after examining the connection between the adobe brick and the fired brick, it does not appear this chimney was part of the initial construction. The adobe bricks appear to have been cut to accommodate the brick chimney, and there is a gap between them.

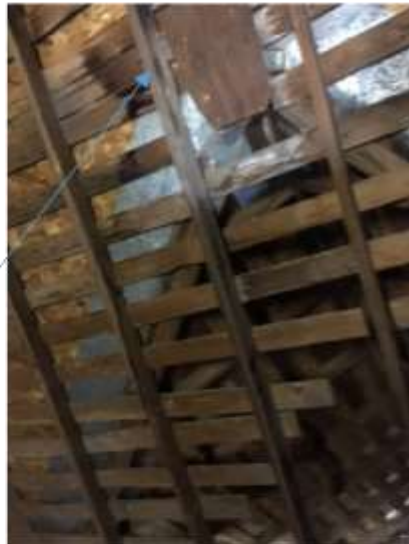
Signs of water penetration at rafters above chimney

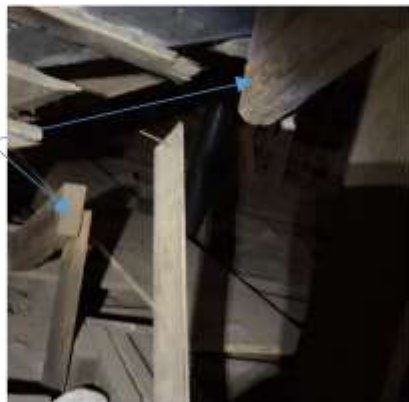
Rafters directly above chimney may have been cut to allow for a metal duct.

the chimney, it is difficult to determine if the chimney previously extended through the roof, or if the rafters were cut to accommodate metal ducting which may have extended from this chimney to the "east" chimney of the interior adobe wall. Existing metal "straps" anchored to nearby rafters may have supported a metal duct exiting the chimney and loose metal ducting was found in the attic nearby.

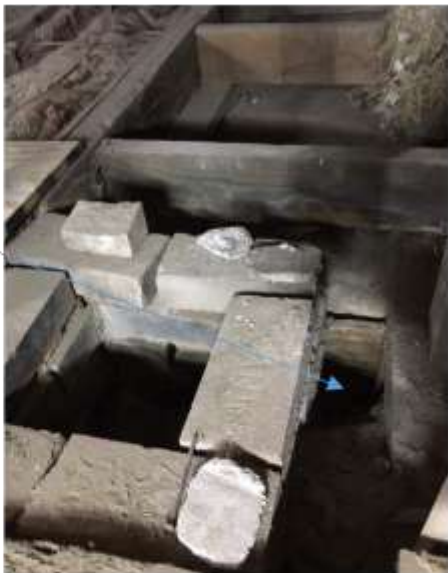
From the attic, gap between the brick chimney and the adobe is visible.

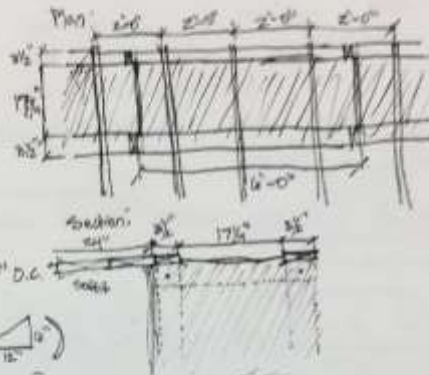
Roof Truss @ Peak of bubble (8' x 8' bay)

- 2x4's on both interior and exterior of top board beam
- Vertical 2x4's in wall with wall spaced every 6'-0" (nailed into top 2x4 beams)
- 1x4's applied to vertical 2x4 supports
- Roof Joists spaced @ 2'-0" o.c. (2x4 wall)
- Feet Sloped @ 6:12 (1/2" 12")

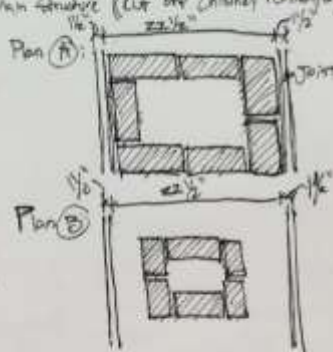
- Brick chimneys originally used in conjunction with coal heating system.
- Cut off when (assumed) hot re-roofing took place after coal became obsolete
- Tops in-line with top of bubble wall.
- Also in rock framing indicate where they originally exited the building.
