**For the Historic Blackwell School (1889-1965)
Marfa, TX**

A Conditions Assessment and Preservation Recommendations

Fieldwork and Report: Jean Fulton, M.A.

Preservation Programs Coordinator and Senior Program Manager
Cornerstones Community Partnerships (Mesilla, NM)

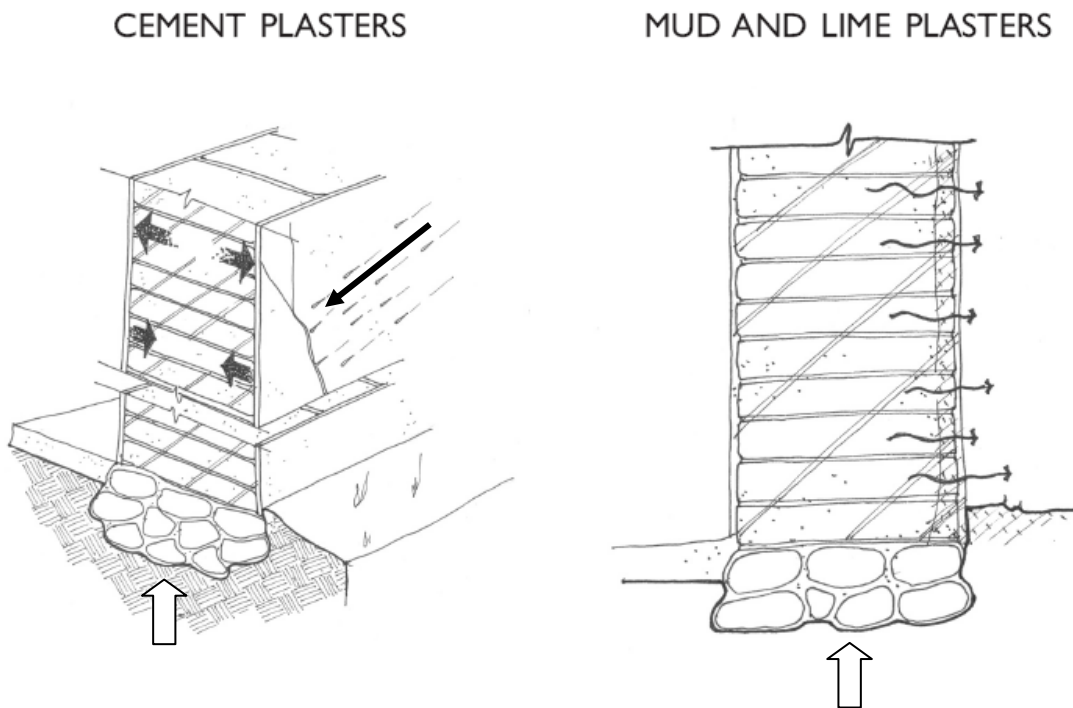
MOISTURE WICKS UP FROM THE GROUND AND ENTERS THROUGH PLASTER CRACKS

(Left) Moisture is trapped within the impermeable cement stucco plasters.

When a rigid cement plaster is applied to an adobe wall, there is a high probability that the plaster will crack from the thermal expansion of the wall mass. Water penetration ensues. Subsequently, the wire mesh used to attach the cement plaster rusts, and the plaster fails. Cement plaster moves at a different rate than adobe does during daily and seasonal temperature changes. This differential movement is the major cause of cement plaster cracking.

Traditional mud and lime plasters, by contrast, are more compatible with the thermal qualities of adobe. Mud and lime plasters are permeable materials. They allow the moisture that has wicked into the walls to evaporate.
